Cameron Balloons U.S. Service Bulletin 9

1. General: This Service Bulletin is issued to inspect the Vapor Pilot Light Hose Male Quick Connect Fitting for cracking.

(a) No.:	9
(b) Revision / Date	Revision 0 / Date: May 12, 2009
(c) Title:	Vapor Pilot Light Hose Male Quick Connect Fitting Cracks
(d) Description:	A crack in the Vapor Pilot Light Hose Male Quick Connect Fitting

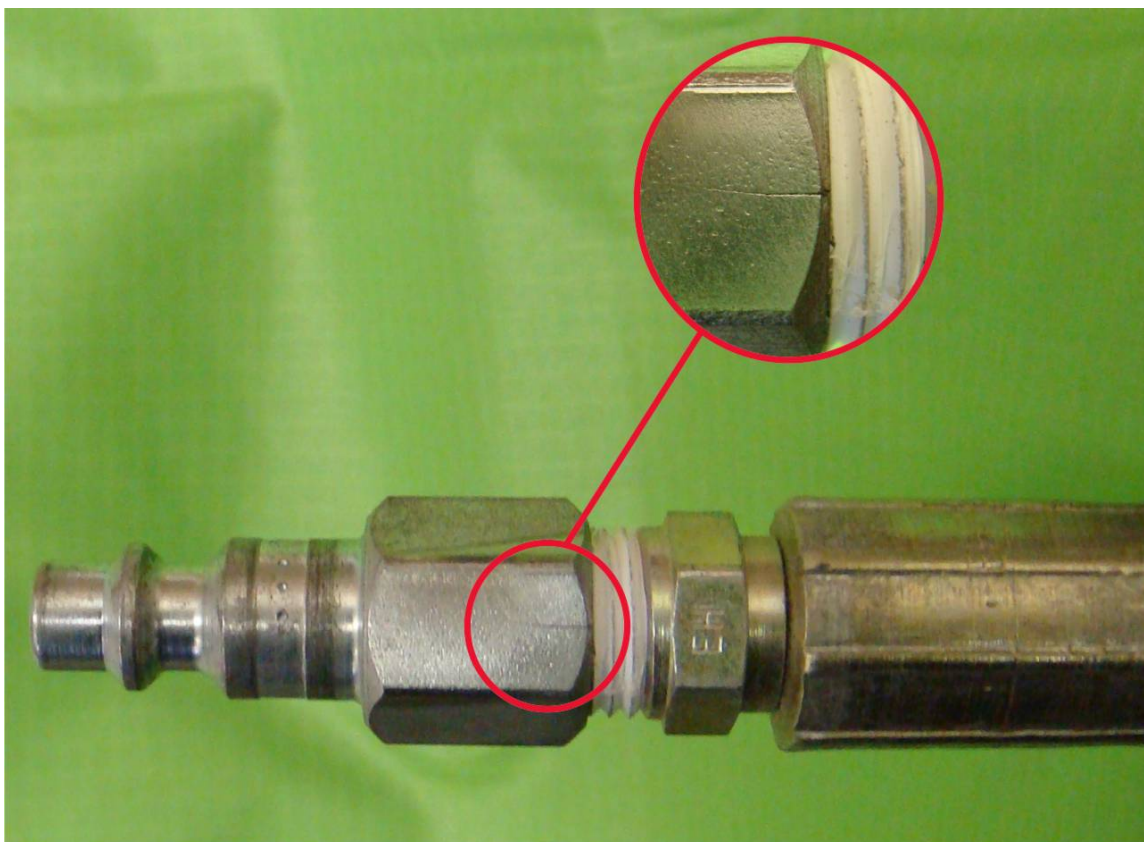
(e) Applicability:	Vapor Pilot Light Hoses delivered between February 2002 & April 2008
(f) Affectivity:	All Vapor Pilot Light Hoses
2. Background:	It has been found that several Vapor Pilot Light Hose Male Quick Connect Fittings may have a visible crack in the hex section of the fitting (see the picture below). There have been no leaks due to this condition due largely to the Teflon tape seal and the very low pressure at this fitting.

5. Accomplishment Instructions:	Inspect both visually and with a gas leak detector (with the hose under pressure) the Vapor Pilot Light Hose Male Quick Connect Fitting for a crack in the hex section.

6. Materials:	If a crack is found, a new Male Quick Connect Fitting will be supplied free of charge. Contact Cameron Balloons US for a replacement.
7. Instructions:	Remove the damaged Male Quick Connect Fitting with a suitable wrench. Remove any Teflon tape residue from the threads on the hose end. Apply new Teflon tape to the hose end. Install the new Male Quick Connect Fitting on the hose. Take care to not over-tighten. The hose end is a male tapered pipe thread and acts a wedge. Over-tightening will split the fitting and cause a crack.
